# Appendix 13.2

UXO Study

## Detailed Unexploded Ordnance (UXO) Risk Assessment

<b>Project Name</b>	Daer Reservoir, Biggar
<b>Client</b>	Natural Power
<b>Site Address</b>	Daer Reservoir, Biggar, Scotland, ML12 6TJ
<b>Report Reference</b>	DA10468-00
<b>Date</b>	28 <sup>th</sup> February 2020
<b>Originator</b>	HOS

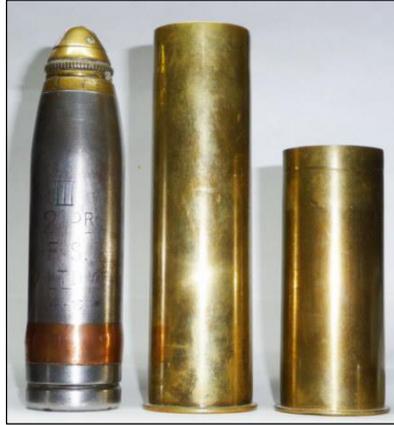
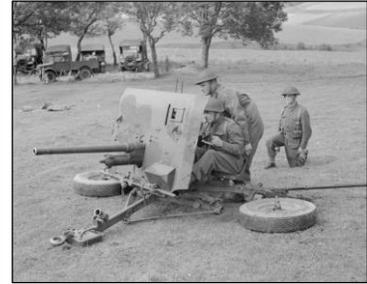
## 2-Pounder Anti-Tank Gun

Total Weight	2lb (0.98kg) or 1.8lb (0.82kg)
Dimensions	40mm x 304mm
Fuze Type	Percussion
Filling	Lyddite charge. Bursting Charge - 0.04lb to 0.14lb Propellant Charge - 0.56lb to 0.67 Total - 0.6lb to 0.81lb
Use	The 2-Pounder was an anti tank field artillery piece. The 2-Pounder was used extensively in Europe between 1939 and 1945
Remarks	The anti-tank 2-Pounder had many Mk's, most with minor modifications to improve the efficiency of the weapon and the ease of production. The gun was often mounted on armoured vehicles and tanks.

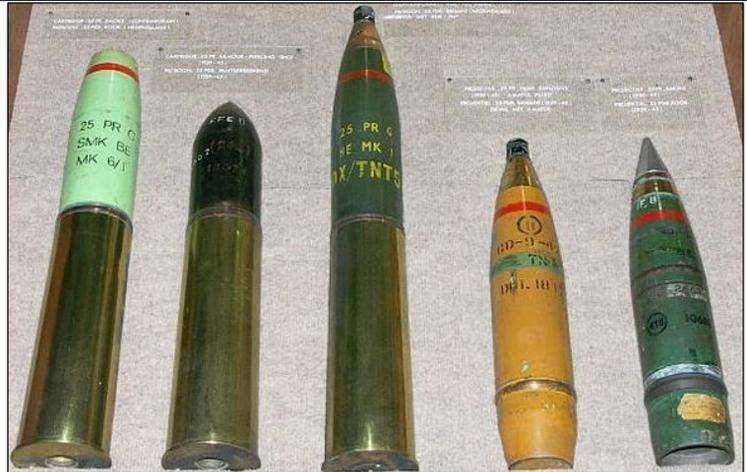
Total Weight	20lb – 25lb (9.07kg – 11.39kg)
Dimensions	Approx. 14" x 3.5" Maximum (355mm x 89mm) Approx. 9.2" x 3.5" Minimum (233mm x 89mm)
Fuze Type	No. 117 DA (Direct Action) fuze although CVT and Proximity fuzes were used later in the war.
Filling	Filling varied dependent on Mk. The HE variety contained amatol or TNT.
Use	The 25-Pounder was an all purpose field gun and saw widespread use throughout the war.
Remarks	A wide variety of 25-Pounder shells were used throughout the war. Versions of the shell included high explosive, armour piercing and smoke.

Examples of 25-Pounder shells. From left to right: Smoke, Armour-piercing, HE (RDX/TNT), HE (Amatol), Smoke (WWII)

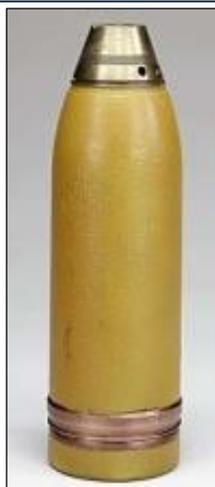
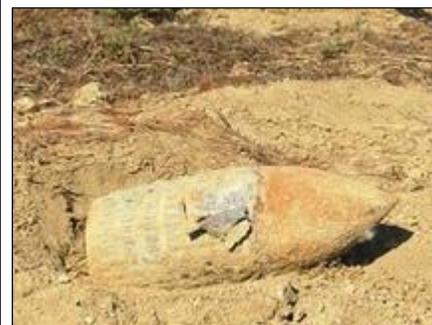
## 18lbs General Purpose HE Howitzer Shell

Weight	18lbs (8 kg)
Explosive Weight	13oz (0.3g)
Fuze Type	Impact
Dimensions	21.7 inches.
Use	The 18lbs howitzer was the most commonly deployed British field artillery in WWI. The HE shell was used to bombard German trenches prior to assaults, for clearing barbed wire, and supporting attacks.
Remarks	Typically a Amatol of Trotyl filling.

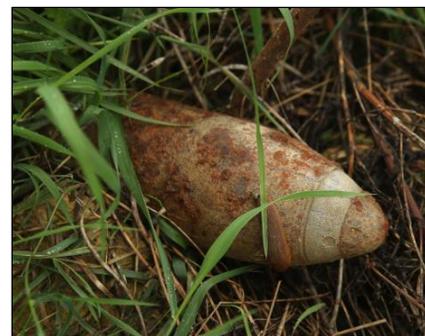
## 18lbs Shrapnel Shell

Weight	18lbs (8 kg)
Explosive Weight	13oz (0.3g)
Fuze Type	Impact
Dimensions	21.7 inches.
Use	The 18lbs shell could be modified to contain shrapnel. Shrapnel pellets would disperse upon detonation.
Remarks	A decreased Amatol of Trotyl filling, filled also with pellets.

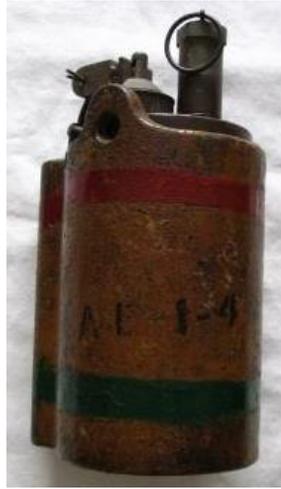
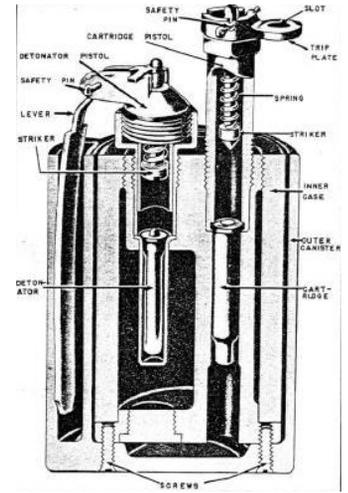
Weight	10lb total, 1lb explosive weight
Dimensions	3 ½ x 5 ½ inches
Fuze	E.P. Mk II Mine Fuze
Filling	Amatol
Use	This mine is a bounding anti-personnel mine designed to cause casualties up to 30 yards.
Identification	The Mk II mine consist of the following components: the outer mine canister, the inner case, the detonator-pistol mechanism and the cartridge-pistol mechanism. They are yellow in colour.

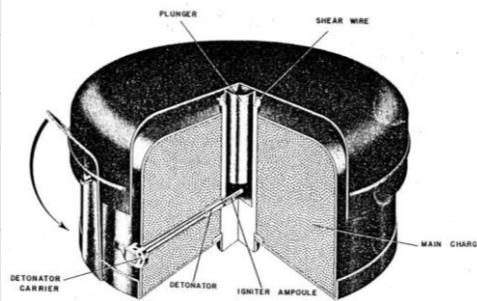
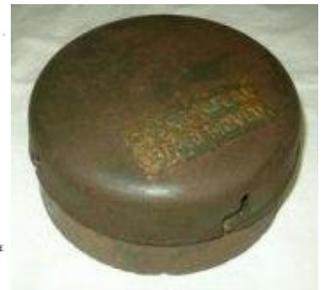
## AT Mine EP MkII

Weight	4 ½ explosive
Dimensions	10 x 4 inches
Fuze	Mine Fuze E.P. Mk II
Filling	TNT
Use	Used as a defence against armoured cars, tanks and other vehicles.
Identification	This mine has three main components,; the loaded mine body, the mine cover and the mine fuzeing arrangement. They should not be disarmed and should be destroyed if found.

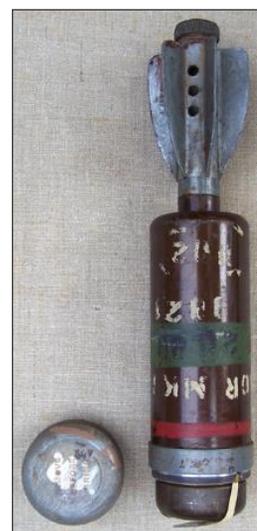
## 2 inch Mortar Smoke

Weight	Approx. 910g (2lb)
Maximum Range	460m (500yards)
Filling	White phosphorus and smoke fill
Dimensions	51 x 290mm (2in x 11.4 in )
Fuze Type	An impact fuze which initiates a bursting charge. This ruptures the mortar bomb's body and disperses the phosphorus filler
Identification	Smoke mortars have a recess and emission holes. May still see light green body paint. Look for stained ground around munition.
Use	As a screening devices for unit movement or to impair enemy field of vision.

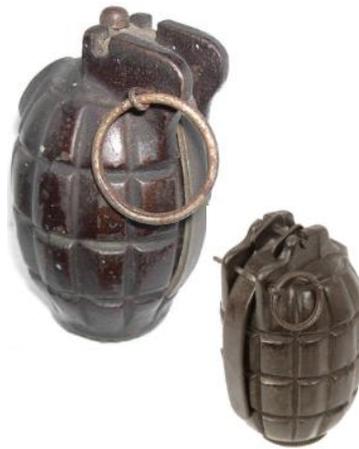
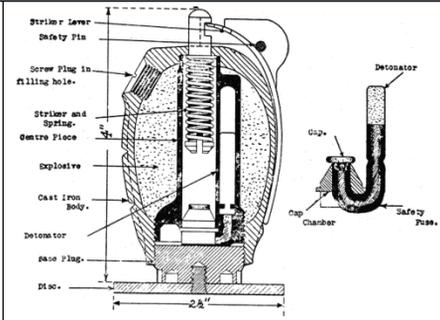
Weight	Approx. 765g filled (1lb 11.25oz)
Explosive Weight	71g (2oz) filling.
Fuze Type	4-7 second delay hand-throwing fuze. No. 6 Detonator
Dimensions	95 x 61mm (4 x 2.4in)
Use	Fragmentation explosive at approx. 30m range 100m range of damage.
Remarks	First introduced in 1915 its classic grooved, cast-iron 'pineapple' design was designed to provide uniform fragmentation. The detonator is inserted before use after removing the base plug.

Left: baseplate and detonator removed

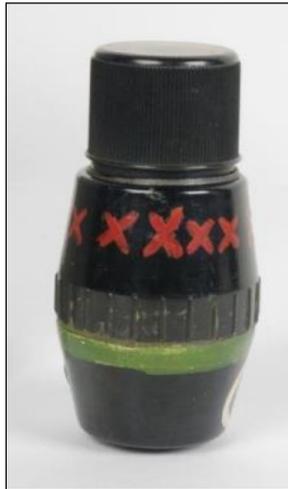
## No. 69 Grenade

Weight	Approx. 383g ( 13.5oz)
Fill Weight	93g (3.25 oz) of either Amatol, Baratol or Lyddite
Fuze Type	'All-ways' Fuze. Comprised of a safety cap, a weighted streamer attached to a steel ball bearing and a safety bolt designed to detonate from any point of impact.
Dimensions	115 x 60mm (4.5 x 2.4 in)
Use	A blast grenade for use as an offensive weapon. Detonator was inserted before use.
Remarks	Introduced December 1940 and made from the plastic Bakelite as opposed to conventional metals. Detection is difficult due to this low metal content.

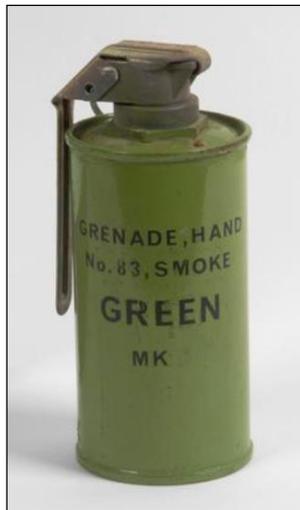
## No. 83 Smoke Grenade

Weight	Approx. 680g ( 1.5lb)
Explosive Weight	Approx. 170-200g. (6-7 oz)
Fuze Type	Originally used a friction system using a match head composition. Later developed to a striker lever ignition system.
Dimensions	Approx. 62 x 140mm (2.44 x 5.5 in)
Use	Use as a target or landing zone marking device and as a screening method for troop / unit movement.
Remarks	This basic design stayed relatively unchanged up to the 1980's. The letters CCC were often etched into the body of the grenade in the colour of the smoke.

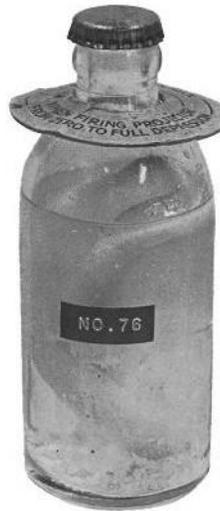
## No. 76 Self Igniting Phosphorous (SIP) Grenade

Weight	Approx. 1lb 3oz
Filling	White Phosphorous and Benzene
Design	The filling was contained in a ½ pint sized glass bottle with water and a strip of rubber. Over time the rubber dissolved to create a sticky which would self ignite when the bottle broke.
Use	Originally intended as an anti-tank incendiary weapon deployed by hand. Designed to be produced cheaply without consuming materials needed to produce armaments on the front line.
Remarks	The Home Guard hid caches of these grenades during the war. Not all locations were officially recorded and some caches were lost and encountered post-war. In all cases, the grenades are still found to be dangerous.

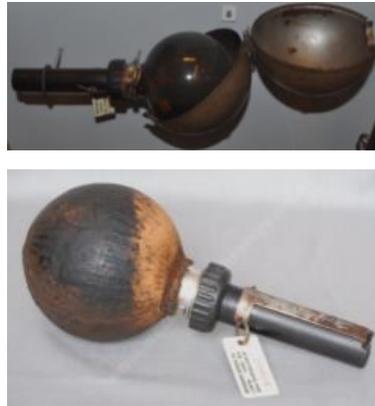
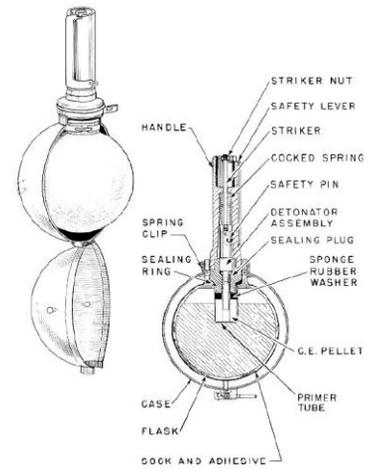
Weight	Approx. 1.1kg (2.25lb)
Filling	Approx. 600g Nobel's No.283 (Nitroglycerine) (1.33lb)
Design	A glass ball on the end of a Bakelite (plastic) handle. The inside of the ball would contain the explosive filling and the outside a very sticky adhesive coating.
Use	An anti-tank grenade primarily issued to the home guard. It required the user to come in very close proximity with the target and smash the glass explosive container against it.
Remarks	Timer fuze was located in the handle. This would explode after 3-6 secs.  9.5in Long 4.5in Diameter

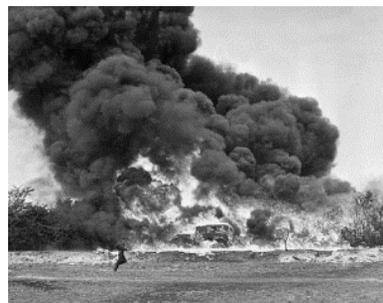
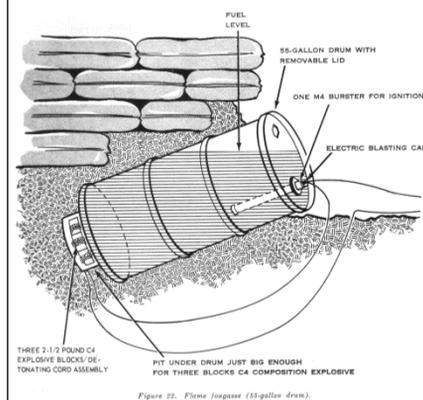
## Flame Fougasse Bomb

Weight	Various
Filling	Initially a mixture of 40% petrol and 60% gas. Ammonal provided the propellant charge.
Design	Usually constructed from a 40-gallon drum dug into a roadside and camouflaged.
Use	As an improvised anti-tank bomb. When triggered the Fougasse could project a beam of burning sticky fuel in a fixed direction from up to 3m (10ft) wide and 27m (30yards) long.
Remarks	A highly unorthodox weapon designed by the Petroleum Warfare Department to address a critical lack of weapons in 1940. 50,000 are estimated to have been distributed around the UK.

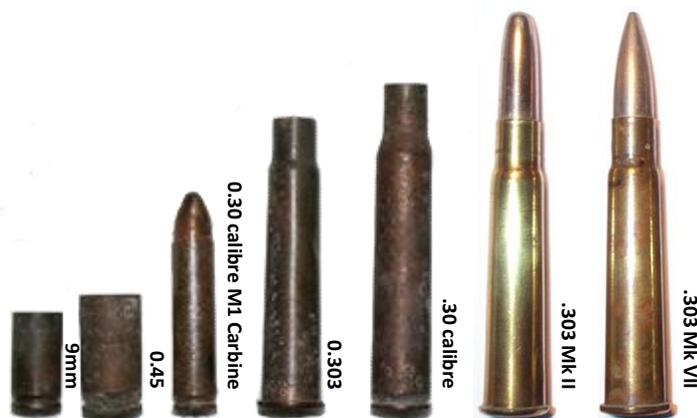
## Examples of British Small Arms Ammunition

Bullet Diameter	7.92mm
Case length	56.44mm
Overall length	78.11mm
Type	Rifle Ammunition
Propellant	Originally black powder. Later Cordite followed by Nitrocellulose
Remarks	First produced in 1889 and still in use today, the .303inch cartridge has progressed through ten 'marks' which eventually extended to a total of around 26 variations.

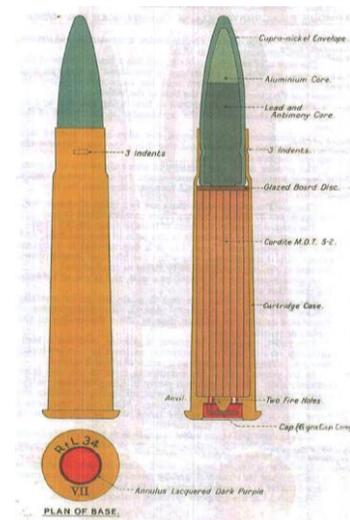
Bullet Type	Colour of tip	Colour of Annulus
Armour Piercing	Green	Green
Ball	None	Purple
Incendiary	Blue	Blue
Observing	Black	Black
Proof	None	Yellow
Tracer Short Range	White	Red
Tracer Dark Ignition	Grey	Red

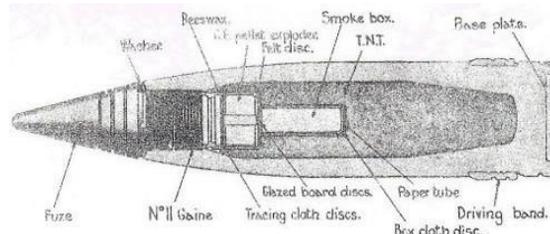
Projectile Weight	28lb (12.6 kg)
Explosive Weight	2.52lbs
Fuze Type	Mechanical Time Fuze
Dimensions	3.7in x 14.7in (94mm x 360mm)
Rate of Fire	10 to 20 rounds per minute
Use	The 3.7in AA Mks 1-3 were the standard Heavy Anti-Aircraft guns of the British Army.
Ceiling	30,000ft to 59,000ft

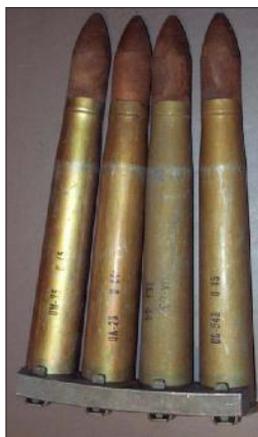
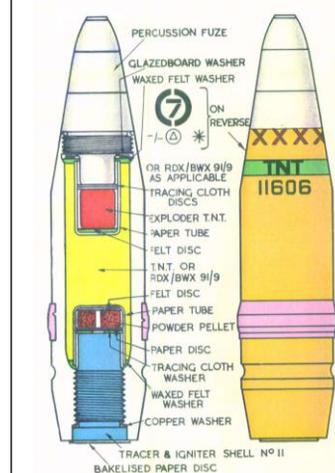
## 40mm Bofors Projectile

Projectile Weight	1.96lb (0.86kg)
Explosive Weight	300g (0.6lb)
Fuze Type	Impact Fuze
Rate of Fire	120 rounds per minute
Projectile Dimensions	40 x 180mm
Ceiling	23,000ft (7000m )
Remarks	Light quick fire high explosive anti-aircraft projectile. Each projectile fitted with small tracer element. If no target hit, shell would explode when tracer burnt out. Designed to engage aircraft flying below 2,000ft

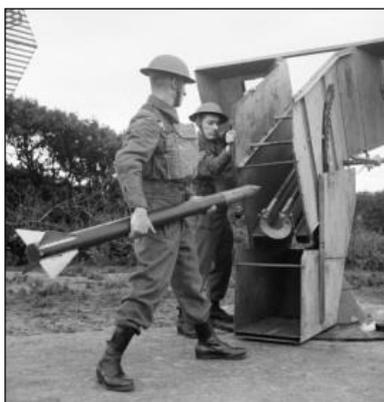
## 3in Unrotated Projectile (UP) Anti-Aircraft Rocket ("Z" Battery)

HE Projectile Weight	3.4kg (7.6lb)
Explosive Weight	0.96kg (2.13lb)
Filling	High Explosive – TNT. Fitted with aerial burst fuzing
Dimensions of projectile	236 x 83mm (9.29 x 3.25in)
Remarks	As a short range rocket-firing anti-aircraft weapon developed for the Royal Navy. It was used extensively by British ships during the early days of World War II. The UP was also used in ground-based single and 128-round launchers known as Z Batteries. Shell consists of a steel cylinder reduced in diameter at the base and threaded externally to screw into the shell ring of the rocket motor

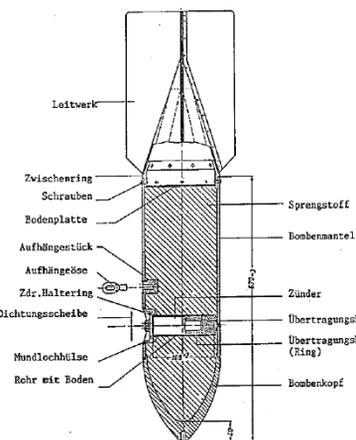
Bomb Weight	40-54kg (88-119lb)
Explosive Weight	25kg (55lb)
Fuze Type	Impact fuze/electro-mechanical time delay fuze
Bomb Dimensions	1,090 x 280mm (42.9 x 11.0in)
Body Diameter	200mm (7.87in)
Use	Against lightly damageable materials, hangars, railway rolling stock, ammunition depots, light bridges and buildings up to three stories.
Remarks	The smallest and most common conventional German bomb. Nearly 70% of bombs dropped on the UK were 50kg.

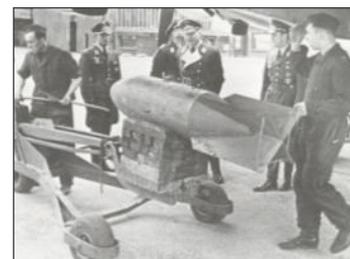
## SC 250kg High Explosive Bomb

Bomb Weight	245-256kg (540-564lb)
Explosive Weight	125-130kg (276-287lb)
Fuze Type	Electrical impact/mechanical time delay fuze.
Bomb Dimensions	1640 x 512mm (64.57 x 20.16in)
Body Diameter	368mm (14.5in)
Use	Against railway installations, embankments, flyovers, underpasses, large buildings and below-ground installations.
Remarks	It could be carried by almost all German bomber aircraft, and was used to notable effect by the Junkers Ju-87 Stuka (Sturzkampfflugzeug or dive-bomber).

SC250 bomb being loaded onto German bomber

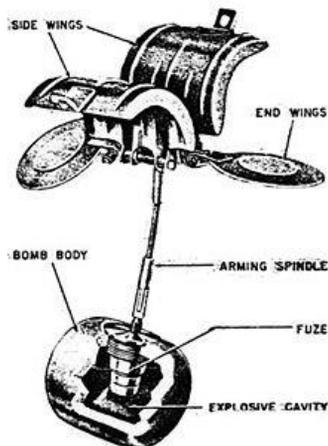
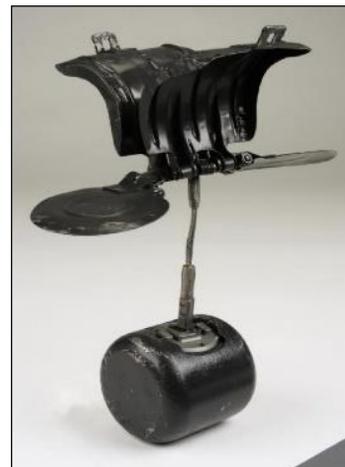
Bomb Weight	Approx. 2kg (4.41lb)
Explosive Weight	Approx. 7.5oz (225 grams ) of Amatol surrounded by a layer of bituminous composition.
Fuze Type	41 fuze (time) , 67 fuze (clockwork time delay) or 70 fuze (anti-handling device)
Body Diameter	3in (7.62 cm) diameter, 3.1in (7.874) long
Use	Designed as an anti-personnel/ fragmentation weapon. They were delivered by air, being dropped in containers of 23-144 sub-munitions that opened at a predetermined height, thus scattering the bombs.
Remarks	Very rare. First used against Ipswich in 1940, but were also dropped on Kingston upon Hull, Grimsby and Cleethorpes in June 1943, amongst various other targets in UK. As the bombs fell the outer case flicked open by springs which caused four light metal drogues with a protruding 5 inch steel cable to deploy in the form of a parachute & wind vane which armed the device as it span.

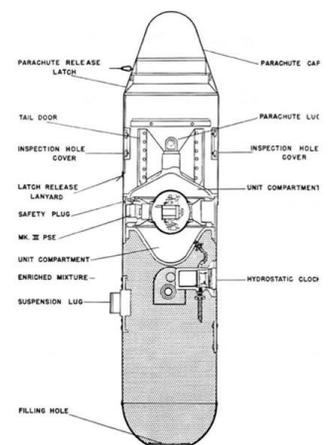
## Parachute Mine (Luftmine B / LMB)

Bomb Weight	Approx. 990kg (2176lb)
Explosive Weight	Approx. 705kg (1,554lb)
Fuze Type	Impact/ Time delay / hydrostatic pressure fuze
Dimensions	2.64m x 0.64m (3.04m with parachute housing)
Use	Against civilian, military and industrial targets. Used as blast bombs and designed to detonate above ground level to maximise damage to a wider area.
Remarks	Deployed a parachute when dropped in order to control its descent. Had the potential to cause extensive damage in a 100m radius.

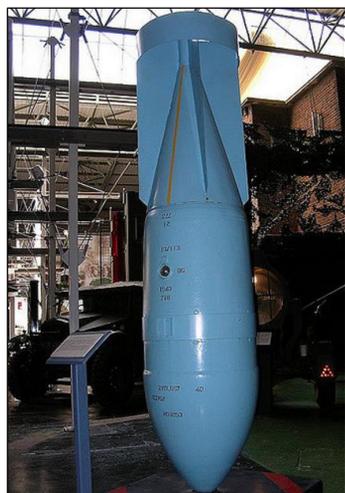
## SC 1000kg

Bomb Weight	Approx. 993-1027kg (2,189-2,264lb)
Explosive Weight	Approx. 530-620kg (1168-1367lb)
Fuze Type	Electrical impact/mechanical time delay fuze.
Filling	Mixture of 40% amatol and 60% TNT, but when used as an anti-shiping bomb it was filled with Trialen 105, a mixture of 15% RDX, 70% TNT and 15% aluminium powder.
Bomb Dimensions	2800 x 654mm (110 x 25.8in)
Body Diameter	654mm (18.5in)
Use	SC type bombs are General Purpose Bombs used primarily for general demolition work. Constructed of parallel walls with comparatively heavy noses. They are usually of three piece welded construction

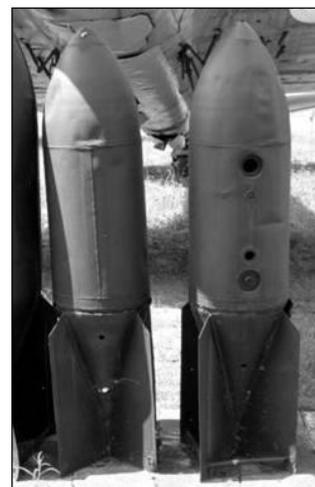
## Flam C-250 Oil Bomb

Bomb Weight	Approx. 125kg (276lb)
Explosive Weight	Approx. 1kg (2.2lb)
Fuze Type	Super-fast electrical impact fuze
Filling	Mixture of 30% petrol and 70% crude oil
Bomb Dimensions	1,650 x 512.2mm (65 x 20.2in)
Body Diameter	368mm (14.5in)
Use	Often used for surprise attacks on ground troops, against troop barracks and industrial installations. Thin casing – not designed for ground penetration

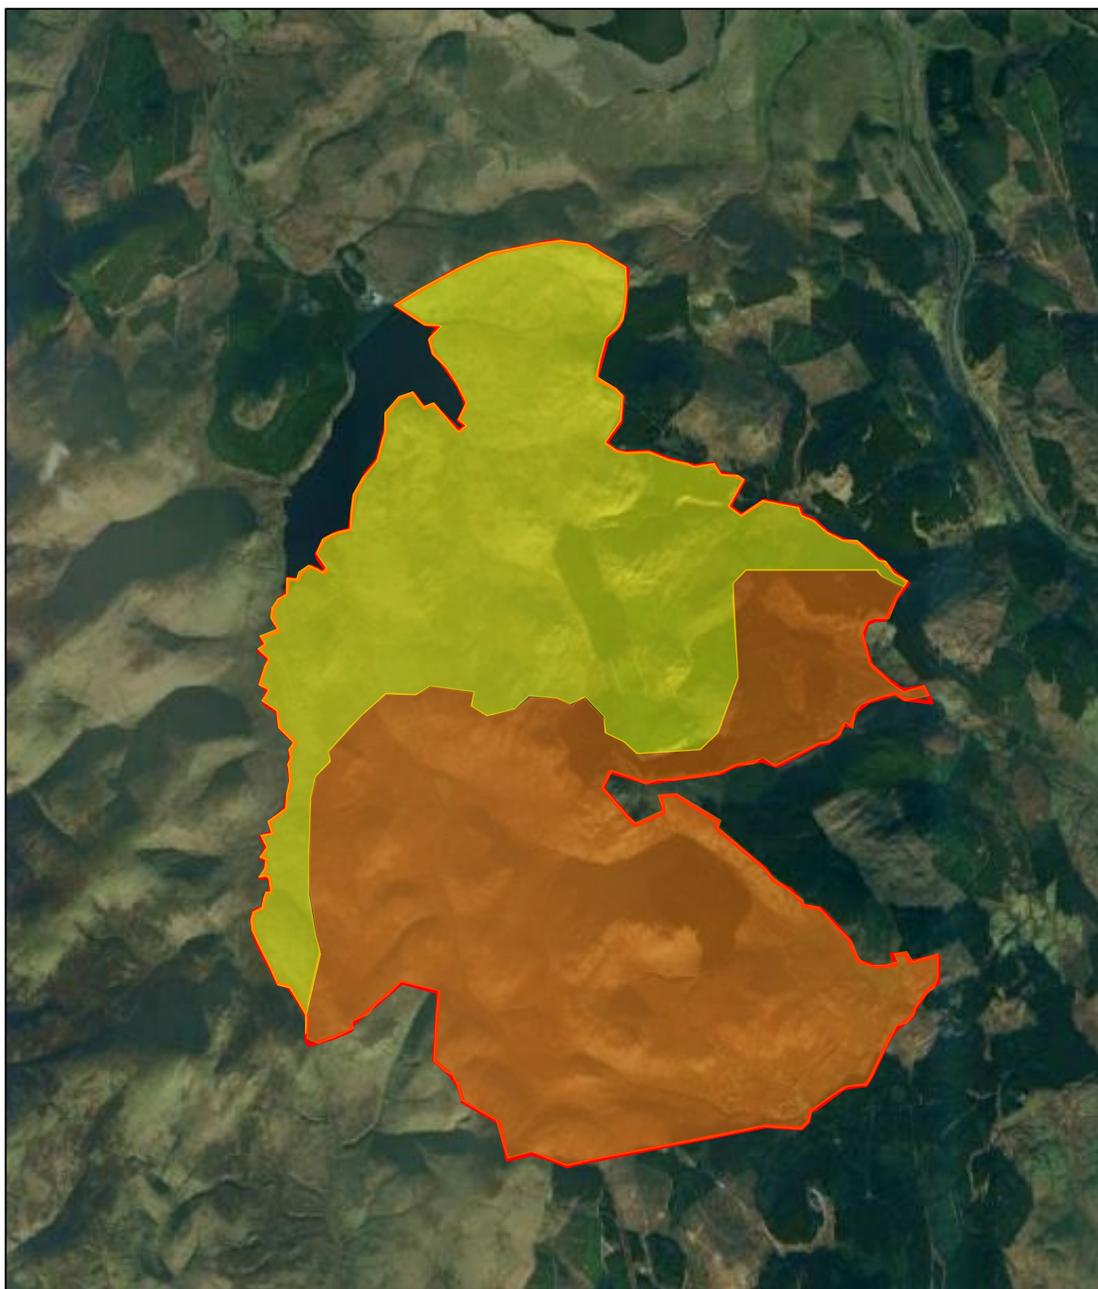
- Low-Medium Risk
- Medium Risk
