# Enoch Hill 2 Wind Farm

Technical Appendix 13B

Peat Landslide Risk Assessment

Doc Ref. 852398-WSPE-RP-R-00001\_P01.2

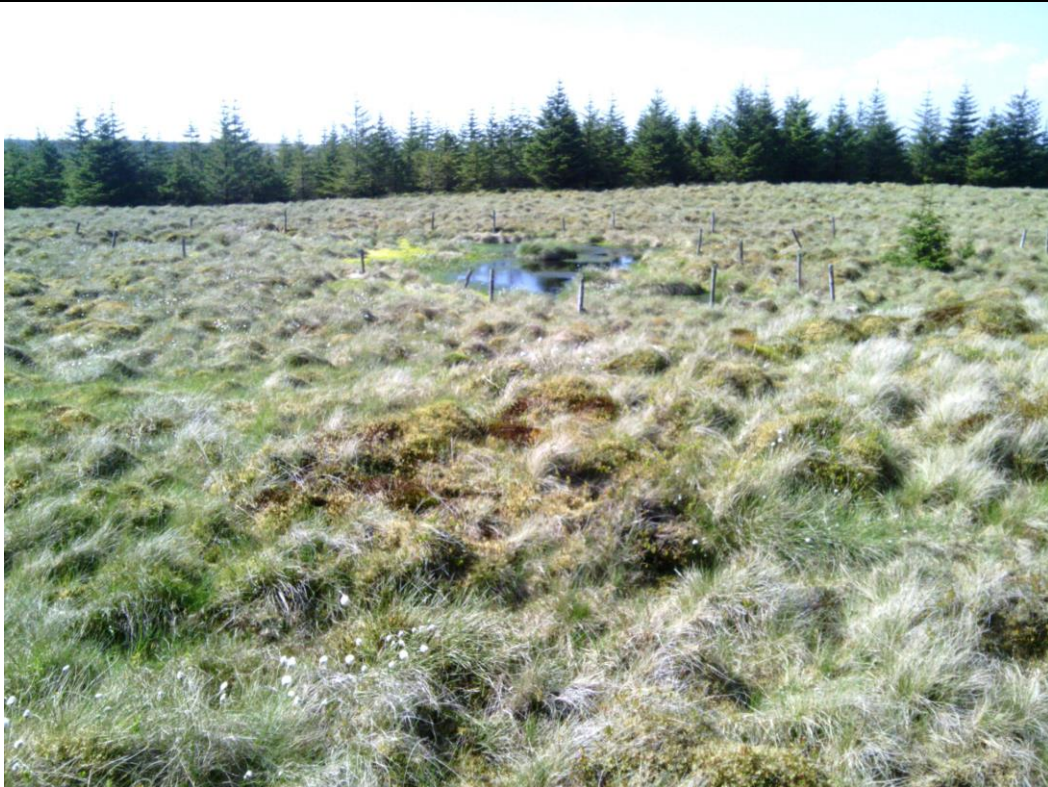
Plate 1: Looking northwest over a bog pool to the north-northeast of Strandlud Hill

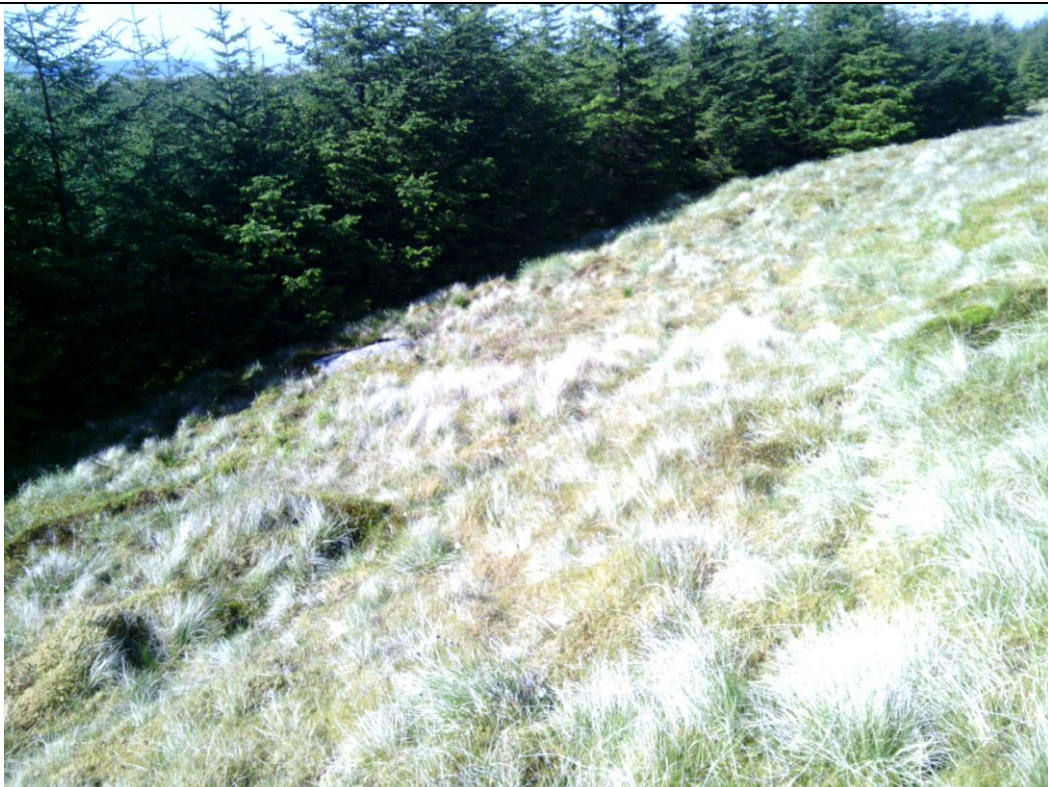
Plate 2: Looking generally north along the northwest slope of Strandlud Hill showing the steeper slopes, dense trees and exposed bedrock.

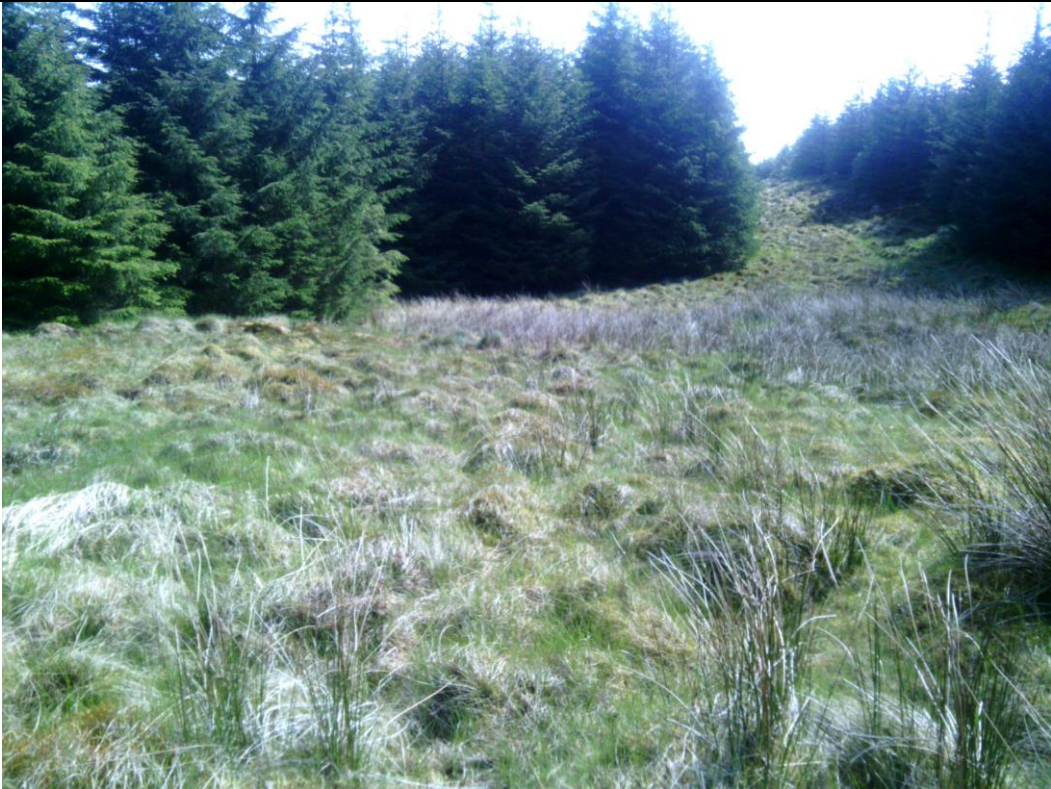
Plate 3: Looking generally south over an area of rushes to the east of WTG-01.

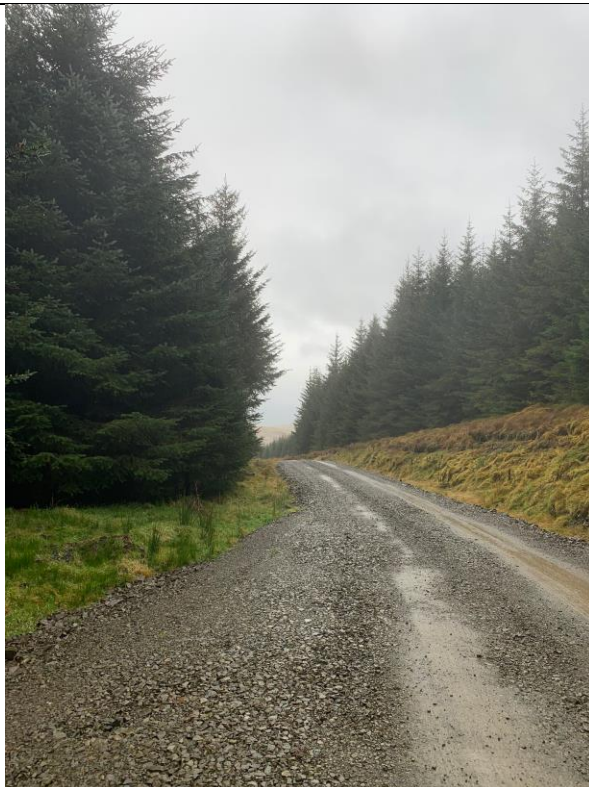
Plate 4: Looking generally southwest along the main access track to the north of Auchincally Hill
